Cast Iron Microstructure Anomalies and Their Causes

Cast Iron Quality Control Committee 5J Report Principle Author:

G.M. Goodrich Bodycote Taussig, Inc. Skokie, Illinois

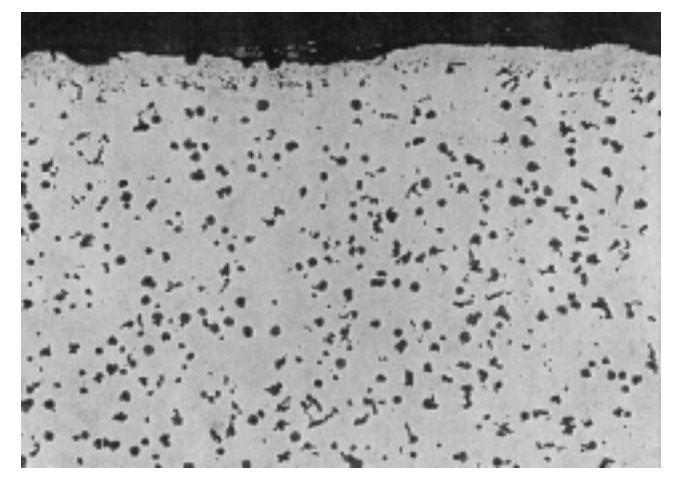
Figures 1 and 2 show unacceptable graphite nodularity that was identified in the cover plate for a floor-level utility box in a major convention center. The designated material for this cover was ASTM A536-80, Grade 65-45-12 ductile cast iron.

The presence of the degenerate graphite illustrated in Figs. 1 and 2 impairs mechanical properties. The presence of primary carbides in the structure can also reduce mechanical properties. In both instances, the ductility, as measured by the percent elongation, is most dramatically reduced. The observed structures can be the consequence of *fade*.

Fig. 1. Poor ductile iron nodularity caused this utility cover plate to fail; (100X, unetched).

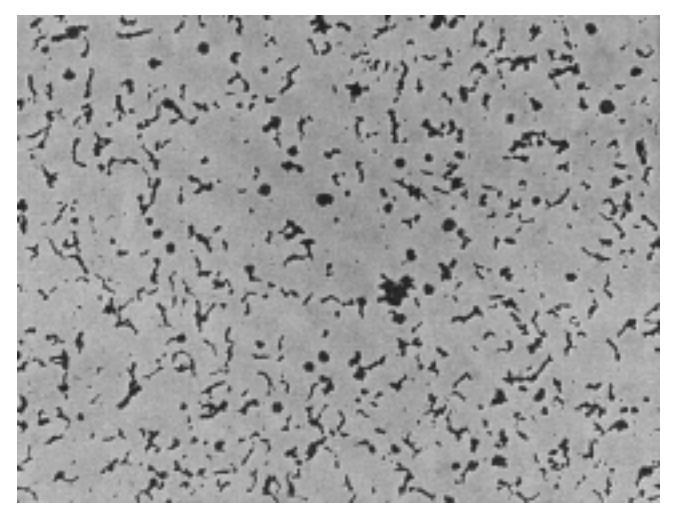
Fig. 2. Photomicrograph of ductile iron shows unfavorable graphite nodule formation; (100X, unetched).

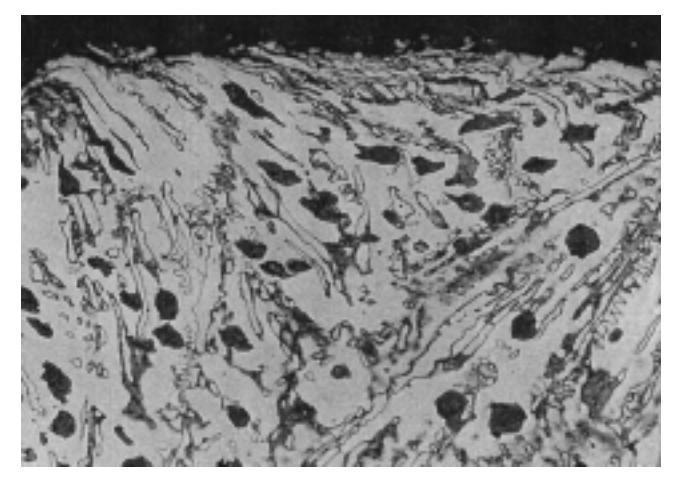
Using the covers from the floor-level utility boxes as examples, Figs. 3, 4 and 5 illustrate the presence of primary carbides in a ferritic structure and in structures that contain both ferrite and pearlite. These utility box covers failed immediately after installation, due to the movement of heavy equipment across them. The ductile iron covers that met the A536-80 requirements for 65-45-12 ductile iron grade performed acceptably without failure.

Fig. 3. Ductile iron microstructure is illustrated at a fracture site. Note pearlite (dark constituents) and ferrite (white constituents). White platelets are primary carbides resulting from inadequate inoculation or inoculant fade; (400X, nital etch).

The principle step in controlling the occurrence of primary carbides in ductile iron calls for close attention to detail concerning inoculation and fade time. The effects of inoculation fade with time and, therefore, processing time within the foundry should be closely controlled. In many instances, modern-day foundries have utilized late-stream inoculation or mold inoculation to counteract effects of fade.

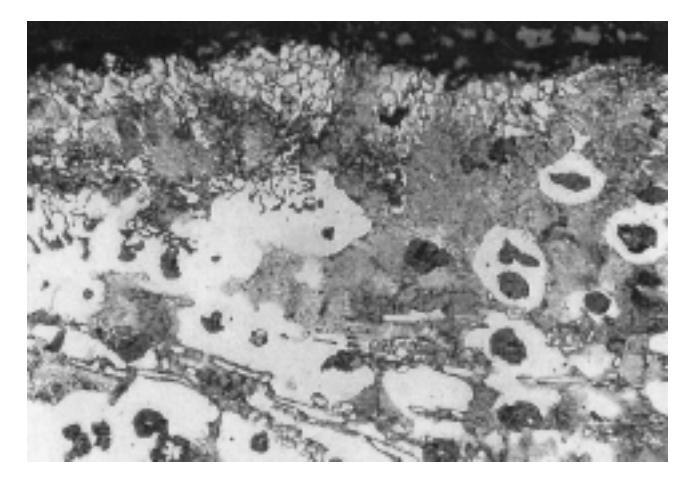
Fig. 4. Ductile iron microstructure shows flake surface graphite and nonspheroidal graphite. Dark matrix is pearlite; white is ferrite. Primary carbide is evidenced by blocky white structures occurring in pearlite and ferrite; (400X, nital etch).

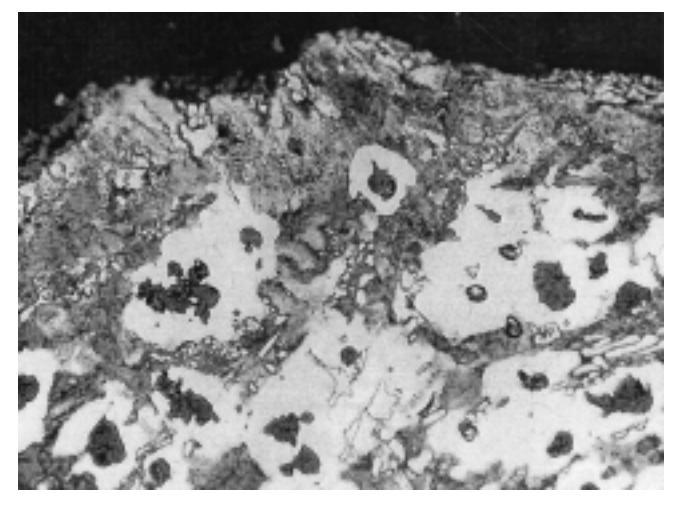
Fig. 5. Ductile iron microstructure illustrates poor graphite nodularity in matrix of pearlite (dark constituent) and ferrite (white regions surrounding graphite). Small, angular, white particles in matrix are primary carbides; (400X, nital etch).

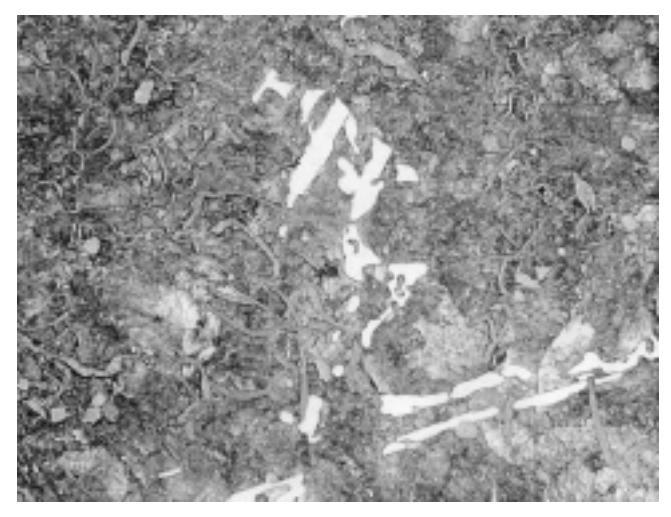
Two microstructure constituents in gray cast iron can cause hard spots, which aggravate machinists. These two constituents are iron carbides and iron phosphides. Figures 14 and 15 show a typical example of iron carbides, and Figs. 16 and 17 show a typical example of iron phosphides.

Fig. 15. Photomicrograph showing primary carbides (white constituent) in a predominantly pearlitic gray iron matrix; (400X, nital etch).

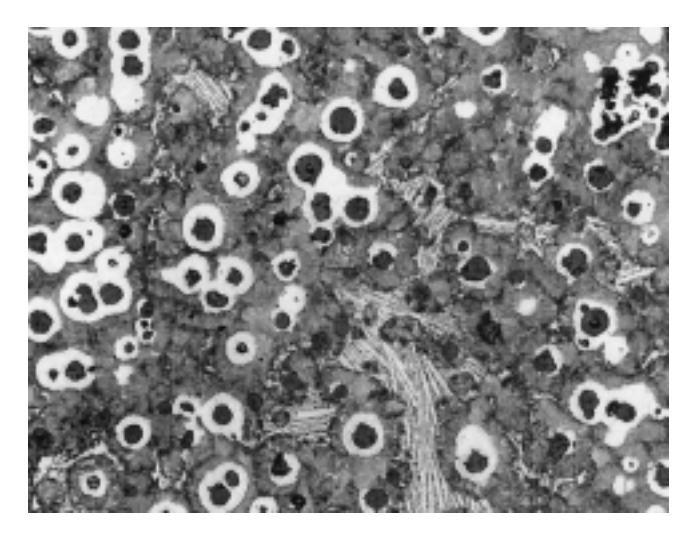
In addition to the inoculating effects and fade effects, some contaminants can cause primary carbides. In ductile iron, chromium is particularly noted for the formation of stable primary carbides that are not easily removed with heat treatment and are not easily removed with proper inoculation. Hydrogen is also noted for causing primary carbides. In this instance, however, the primary carbides can occur in the last iron to solidify because of H segregation to the liquid during solidification. When this occurs, a particular carbide form results, known as inverse chill. Figure 13 shows an example.

Fig. 13. Ductile iron microstructure illustrating inverse chill primary carbides in a pearlitic ductile iron. Needle-like carbides toward middle bottom of photograph are inverse chill; (200X, nital etch).

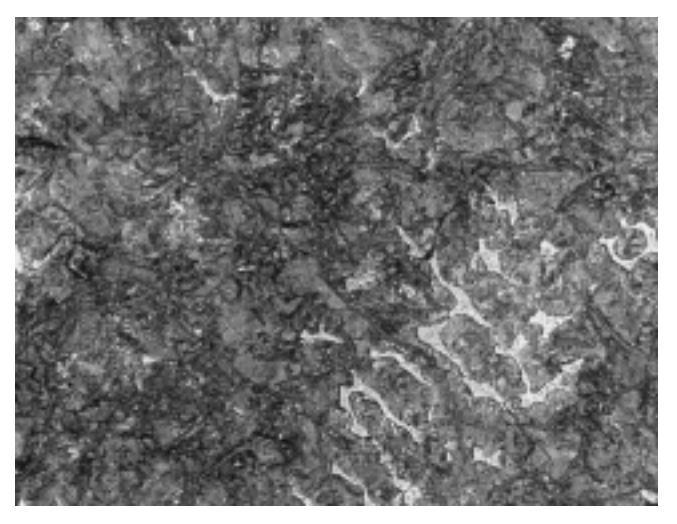
Fig. 16. Photomicrograph showing steadite in a predominantly pearlitic gray cast iron; (200X, nital etch).

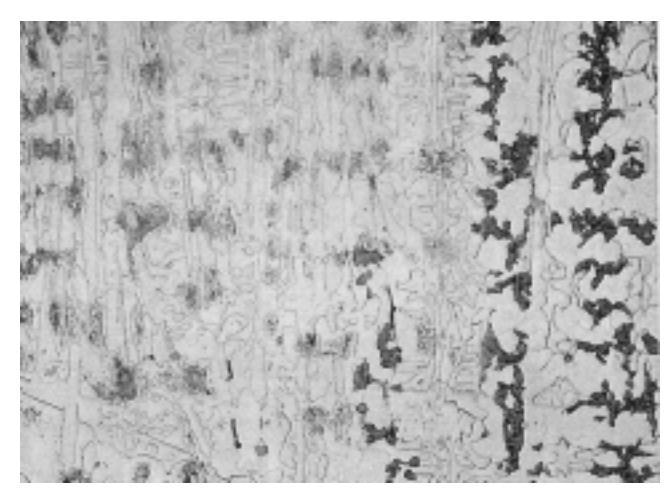
Fig. 14. Photomicrograph showing primary carbides in gray cast iron with a predominantly ferrite matrix. Black constituent at right is graphite that appears to have precipitated after solidification; (100X, nital etch).

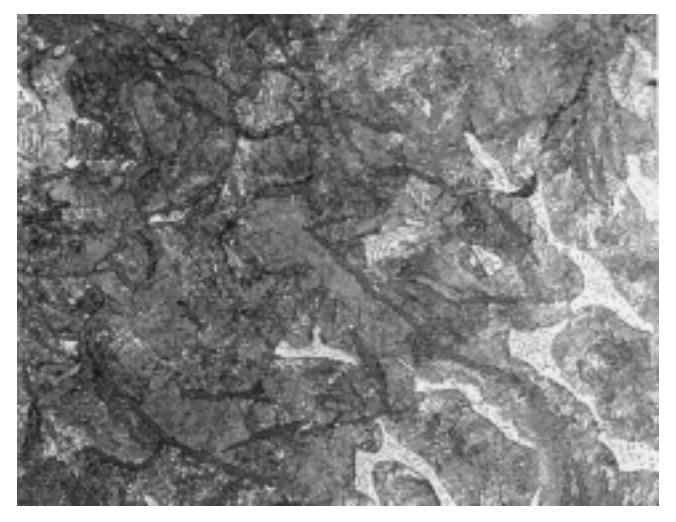
Fig. 17. Photomicrograph showing same area seen at lower magnification in Fig. 16 to illustrate "pepper marks" within steadite plate constituent; (400X, nital etch).

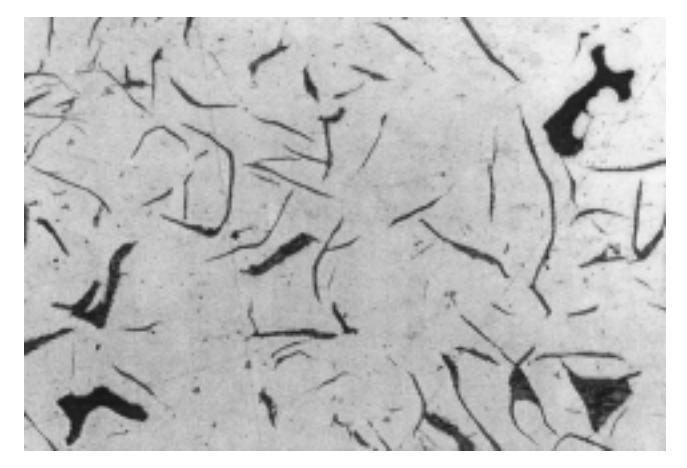
Since these eutectics are the last to solidify, they can be present in the cast iron structure as liquid surrounded by solid, and can be drawn from thin sections to feed thick sections. The consequence can be microscopic shrinkage voids in thin sections. These voids have a shape that is similar to the carbide and steadite constituents that would be found in the structure. Figures 20–23 show an example of the microscopic voids that form from drawing the liquid eutectic phases from thin sections.

Fig. 20. Photomicrograph showing presence of a "shrinkage" void in a thin section at upper right; (200X, unetched condition).

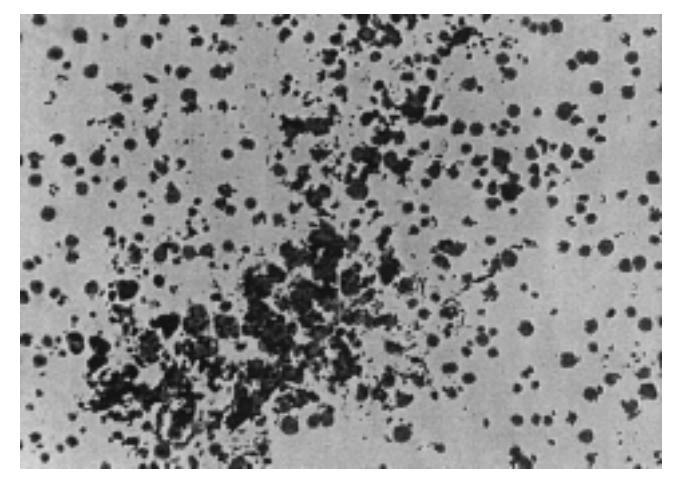
Fig. 24. Ductile iron microstructure with a dross type defect. This dross defect results from a reaction between magnesium dissolved in iron and oxygen in surrounding air; (100X, unetched condition).

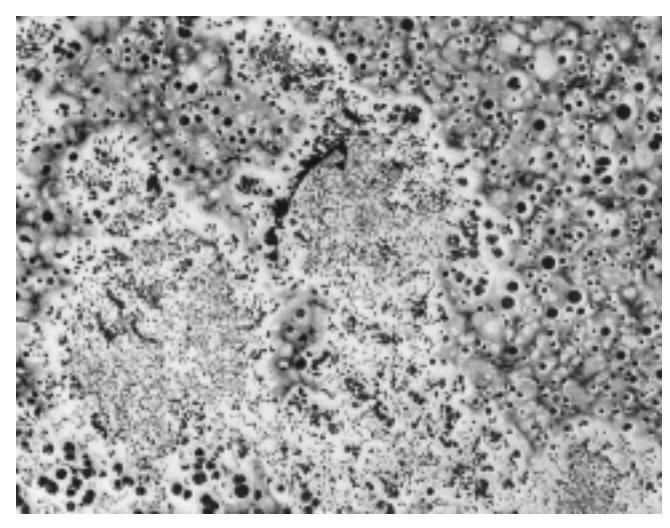
Fig. 25. Photomicrograph illustrating a dross defect in ductile iron. Dark constituent is pearlite; white constituent is ferrite. Note that ferrite concentrates with dross structure; (50X, nital etch).

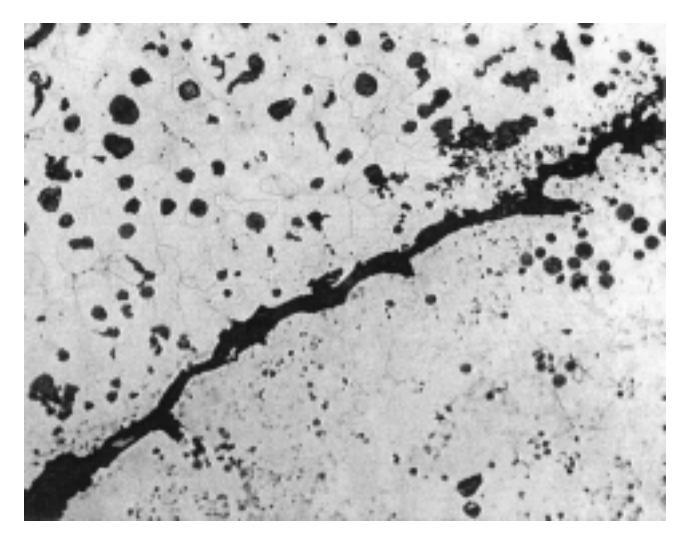
Fig. 26. Photomicrograph illustrating a line of demarkation between a "normal" structure and a partially dissolved inoculant area (200X, unetched condition) (see Figs. 27 and 28).

Sometimes, the dross is associated with undissolved or partially dissolved inoculant. Figure 26 shows an example. In this instance, the structure on one side of a demarkation line from the dross will have a normal silicon level, whereas the structure on the opposite side will have a high Si level. Energy dispersive x-ray (EDX) spectrographic analysis has been helpful in identifying this type of dross defect. Figures 27 and 28 show a typical example of analysis in the normal structure vs. analysis in the dross region.

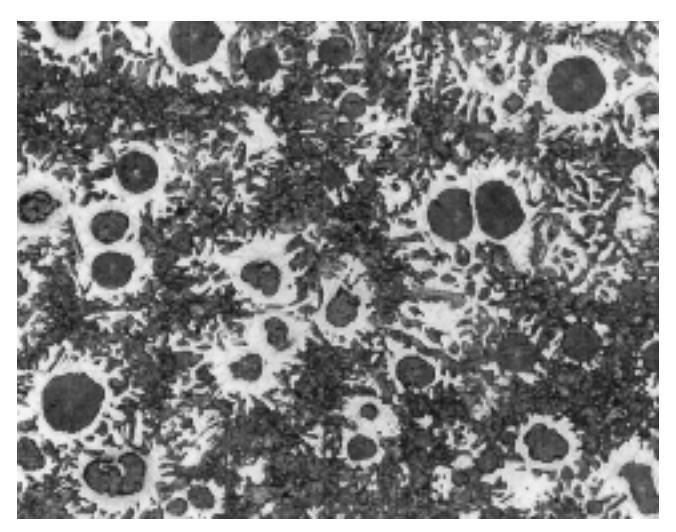
Fig. 35. Photomicrograph of ductile cast iron. This structure was intended to be normalized (100% pearlite); (200X, nital etch).

Analyzing microstructures can sometimes be confusing. For example, the two microstructures shown in Figs. 35 and 36 contain pearlite (the dark constituent), ferrite (the white constituent) and nodular graphite. All of these constituents are normally expected for ductile iron microstructures. However, the shapes and the constituents as shown in these photomicrographs are not normal. Both structures resulted from heat treatment. The structure was the consequence of a normalizing heat treatment intended to produce 100% pearlite. As these structures clearly show, the goal was not achieved.

As a consequence, the austenite that was present transformed to the desired pearlite or ferrite constituent. However, the ferrite or pearlite that was present in the structure, but was not transformed, remained intact as the sample was cooled. The structures shown in the photomicrographs reflect both the transformed constituents and the untransformed constituents. The untransformed constituents are the cause of the unusual shapes in the photomicrographs.

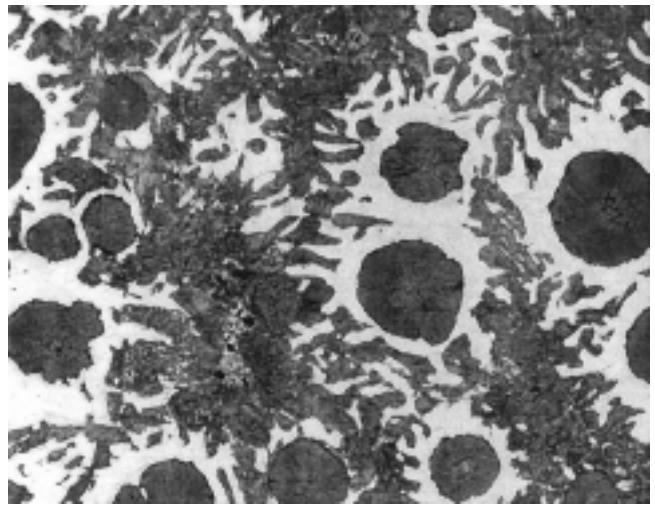
Fig. 36. Photomicrograph of same area shown at lower magnification in Fig. 35. This structure was intended to be annealed (100% ferrite); (400X, nital etch).

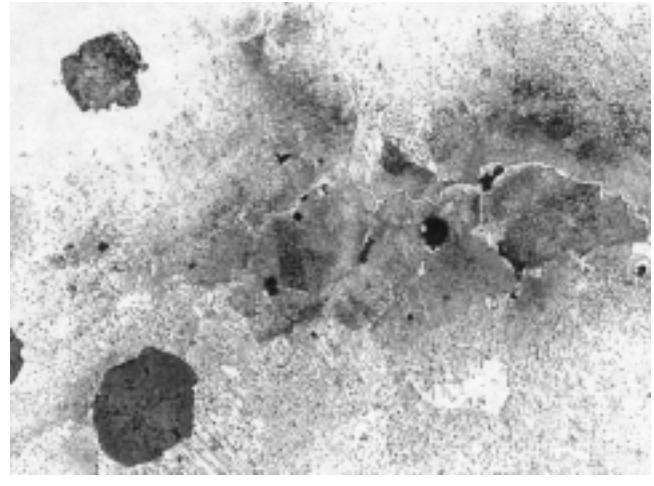
In Problem 1, the microstructure at the tensile fractured surface had a required graphite nodularity (greater than 80%) and pearlite content (greater than 50%), but the structure had a high incidence of intercellular carbides (Fig. 42). As shown in Fig. 43, EDX spectrographic analysis revealed these carbides were high in titanium, vanadium, molybdenum and niobium. These carbides significantly detracted from the ability of the casting to meet the elongation requirements.

Fig. 42. Photomicrograph showing high incidence of intercellular carbides in casting. See Fig. 43 for composition of carbides; (400X, nital etch).

Correcting these problems required different approaches. For Problem 1 (failing to meet the elongation requirement), closer scrutiny of the charge material was required to minimize the influx of tramp elements.

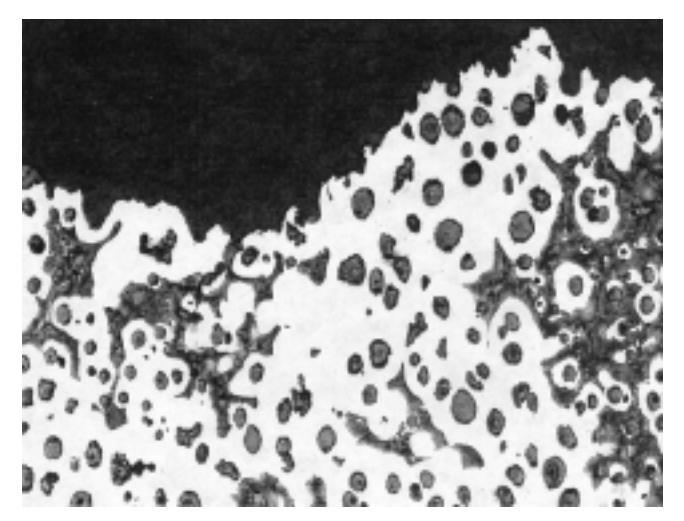
In Problem 2, the microstructure had acceptable nodularity, but the ferrite content was excessive. Figure 44 shows that the ferrite content was about 70% of the matrix. For this grade, the matrix should be in excess of 50% pearlite. Excessively high ferrite content detracts from the yield strength.

Fig. 44. At 100X, this casting is 70% ferrite (white area) and only 30% pearlite—20% below its specified pearlitic minimum.

For Problem 2 (failing to meet the yield strength requirement), either an increase in the amount of pearlite stabilizers was required or the foundry needed to shake out the castings at a temperature hot enough to force rapid cooling from "red heat."

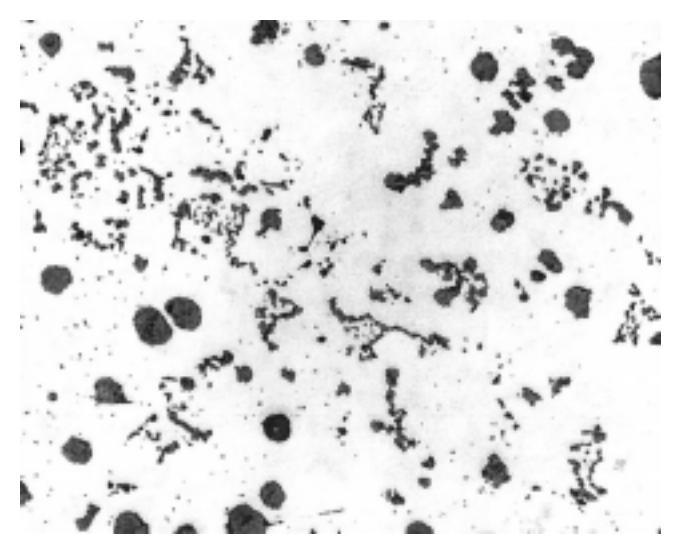
In Problem 3, the microstructure exhibited an acceptable pearlite content (Fig. 45), but the graphite nodularity (Fig. 46) was not acceptable. Poor nodularity negatively affects both the yield strength and elongation.

Fig. 46. At 100X, this photomicrograph shows microstructure's low graphite nodularity.

For Problem 3 (failing to meet both yield strength and elongation requirements), the magnesium/cerium content was not adequate as the result of fade or ineffective treatment.

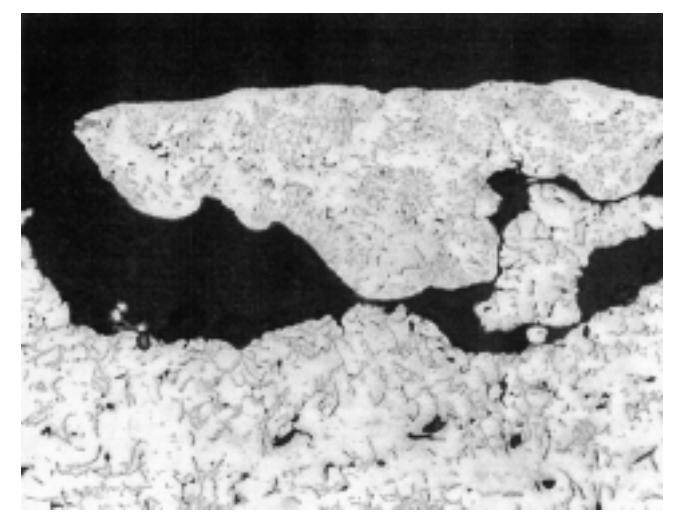
Fig. 47. Photomicrograph illustrating a cross section through one of the defective regions on casting. Note difference in graphite structure between three different "layers." These differences are characteristic of laps and cold shuts; (50X, unetched condition).

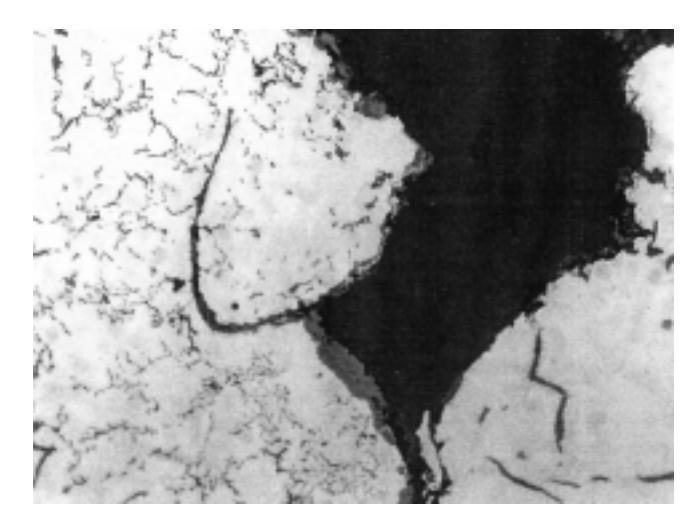
Fig. 48. Photomicrograph illustrating same area shown at lower magnification in Fig. 46. Note how graphite film at center left has been folded into metal. Also note that these individual "layers" have a graphite film liner; (400X, unetched condition).

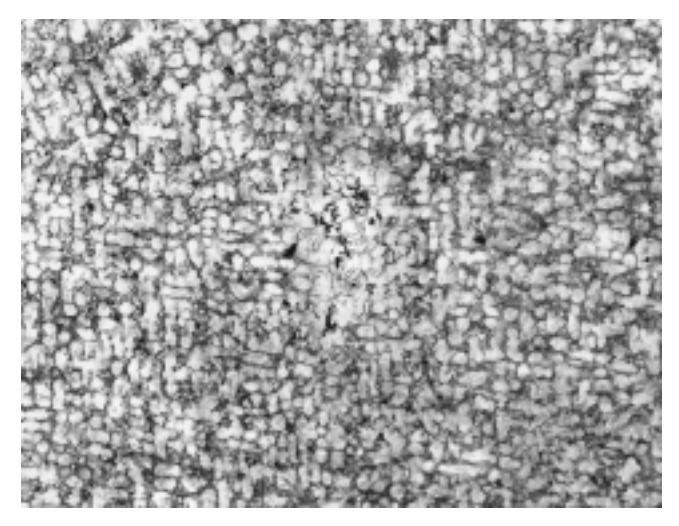
Fig. 51. Photomicrograph showing "hard spot;" (50X, nital etch).

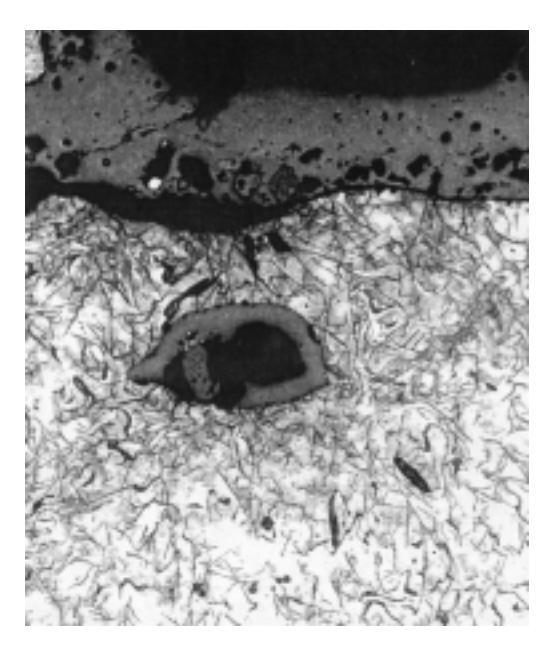
With the new mold filter technology being used today, it has been found that, occasionally, portions of the filter become entrapped in the iron. This is shown in Fig. 56. Apparently, the quality of the iron in the immediate vicinity of the filter segment can be unaffected, as can be seen by comparing Figs. 57 with 58 and 59. However, depending upon what materials might be trapped on the filter, the iron in the immediate vicinity of the filter segment could be compromised. Sometimes, cold shuts and degenerate graphite can occur, as shown in Fig. 60.

Fig. 56. Photomicrograph showing a cross section where a filter segment was trapped in microstructure; (50X, nital etch).

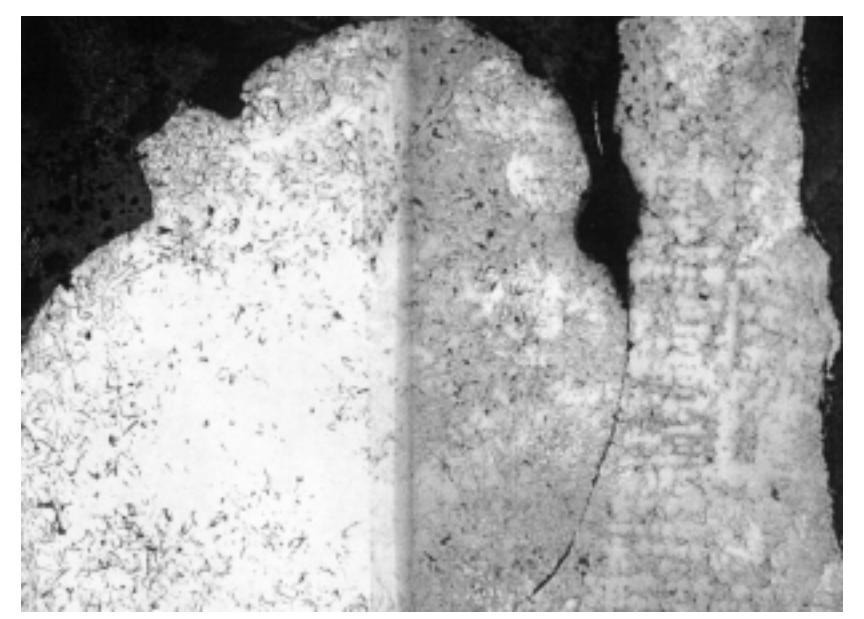
Fig. 60. Photomicrograph showing quality of cast iron in vicinity of a filter segment where casting has sustained a cold shut and degenerate graphite; (50X, unetched condition).

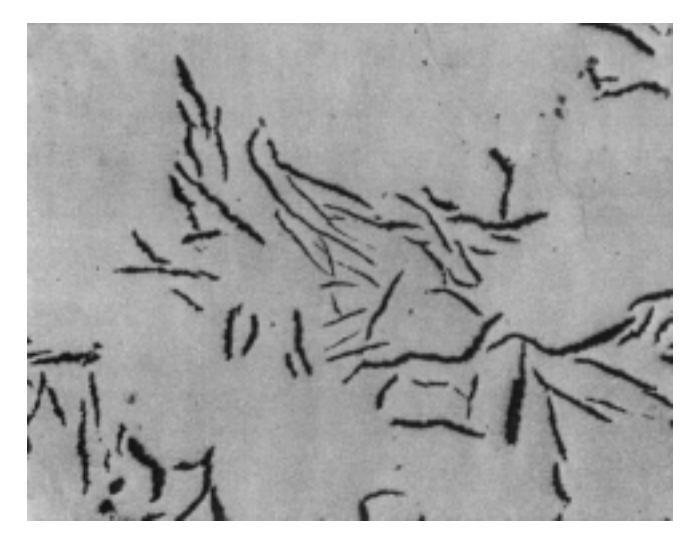
Fig. 61. Photomicrograph illustrating "fat" graphite morphology associated with gray cast iron when nitrogen content becomes excessive (greater than 150 ppm); (100X, unetched condition).

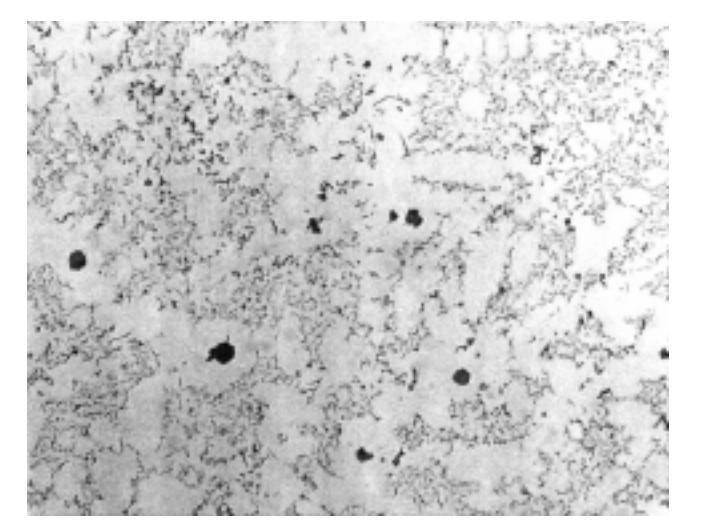
The calcium content in gray cast iron can increase locally, beyond trace levels approaching 0.5%, with some inoculants that have failed to completely dissolve. Calcium is a graphite nodulizing agent, although it is rarely used for this purpose. The microstructure anomaly that occurs with high Ca in gray cast iron is an occasional spheroidal graphite particle. Figure 62 shows an example.

Fig. 62. Photomicrograph showing spheroidal graphite in a gray iron casting; (400X, unetched condition)
