Cast Iron Microstructure Anomalies and Their Causes

Cast Iron Quality Control Committee 5J Report Principle Author:

G.M. Goodrich Bodycote Taussig, Inc. Skokie, Illinois

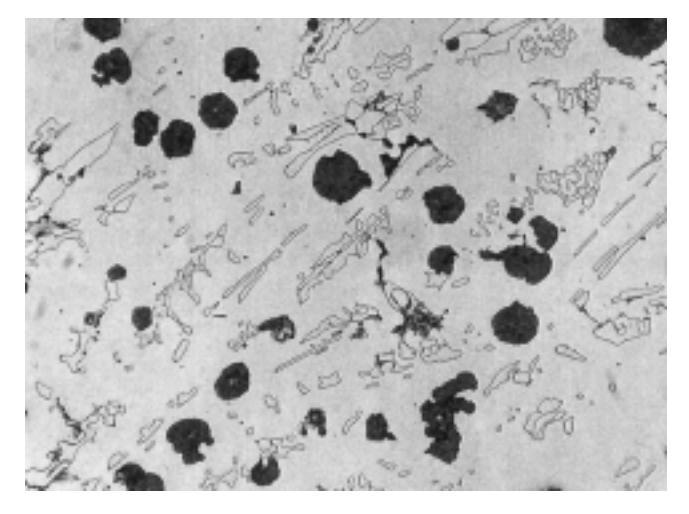
Fig. 6. Ductile iron photomicrograph with a ferritic matrix containing primary carbides. Predominant white matrix structure is ferrite; white angular constituents with ferrite are primary carbides; (400X, nital etch).

In addition to the inoculating effects and fade effects, some contaminants can cause primary carbides. In ductile iron, chromium is particularly noted for the formation of stable primary carbides that are not easily removed with heat treatment and are not easily removed with proper inoculation. Hydrogen is also noted for causing primary carbides. In this instance, however, the primary carbides can occur in the last iron to solidify because of H segregation to the liquid during solidification. When this occurs, a particular carbide form results, known as inverse chill. Figure 13 shows an example.

The principle step in controlling the occurrence of primary carbides in ductile iron calls for close attention to detail concerning inoculation and fade time. The effects of inoculation fade with time and, therefore, processing time within the foundry should be closely controlled. In many instances, modern-day foundries have utilized late-stream inoculation or mold inoculation to counteract effects of fade.

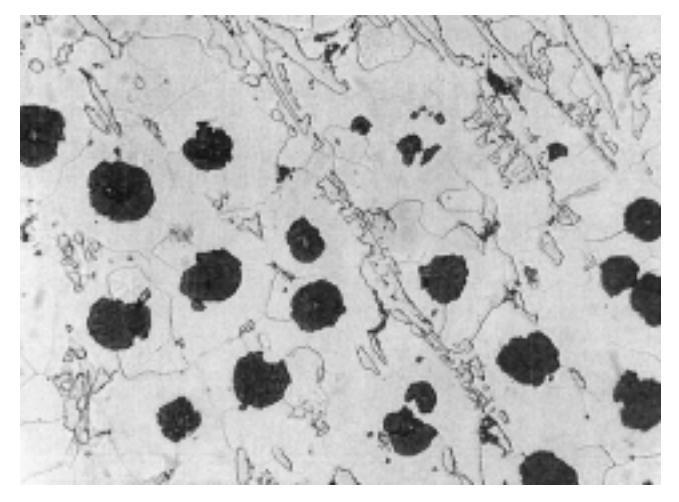
Fig. 7. Ductile iron photomicrograph with a ferritic matrix containing primary carbides. Predominant white matrix structure is ferrite; white angular constituents within ferrite are primary carbides; (400X, nital etch).

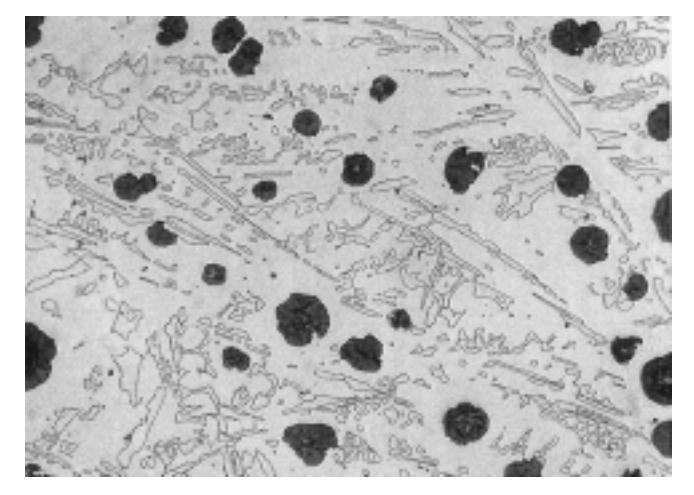
Fig. 8. Ductile iron photomicrograph with a ferritic matrix containing primary carbides. Predominant white matrix structure is ferrite; white angular constituents within ferrite are primary carbides; (400X, nital etch).

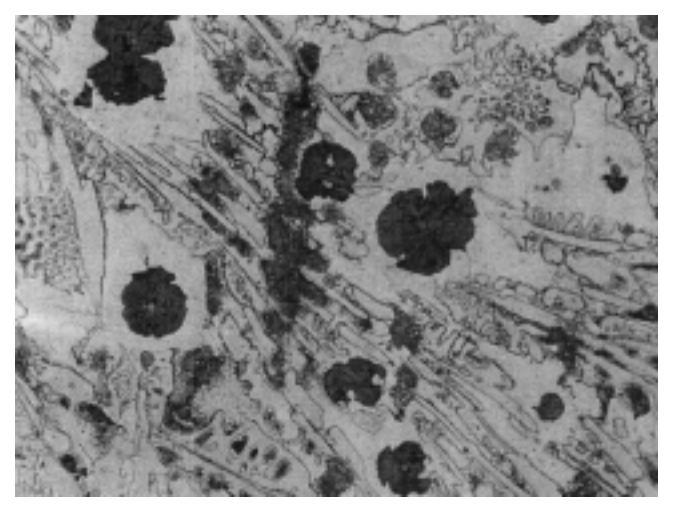
Fig. 9. Ductile iron photomicrograph illustrating primary carbides in a pearlitic ductile iron. Matrix is predominantly pearlite. The white angular constituents within pearlite are primary carbides; (400X, nital etch).

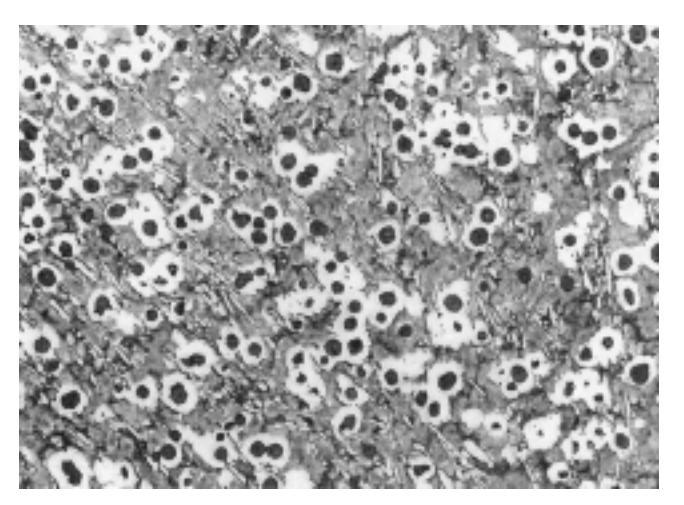
Fig. 10. Ductile iron photomicrograph illustrating primary carbides in a pearlitic ductile iron. Matrix is predominantly pearlite. The white angular constituents within pearlite are primary carbides; (200X, nital etch).

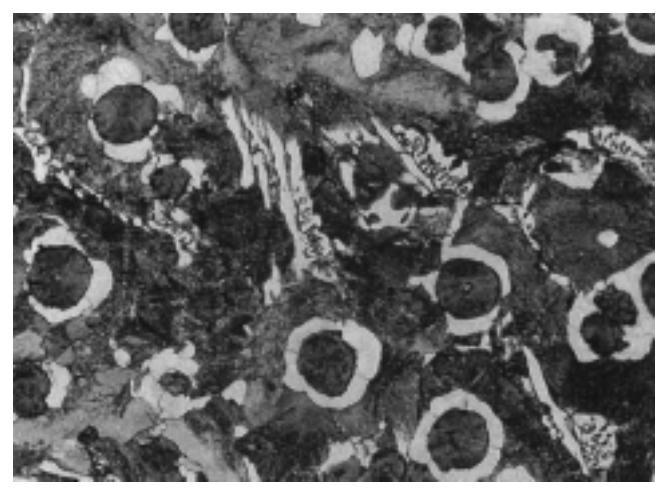
Fig. 11. Ductile iron photomicrograph illustrating primary carbides in a pearlitic ductile iron. Matrix is predominantly pearlite. The white angular constituents within pearlite are primary carbides; (400X, nital etch).

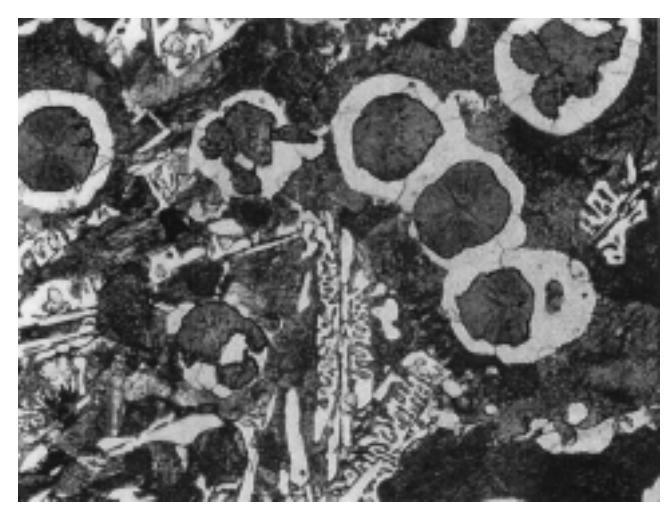
Fig. 12. Ductile iron microstructure illustrating primary carbides in a pearlitic ductile iron. Matrix is predominantly pearlite. The white angular constituents within pearlite are primary carbides; (400X, nital etch).

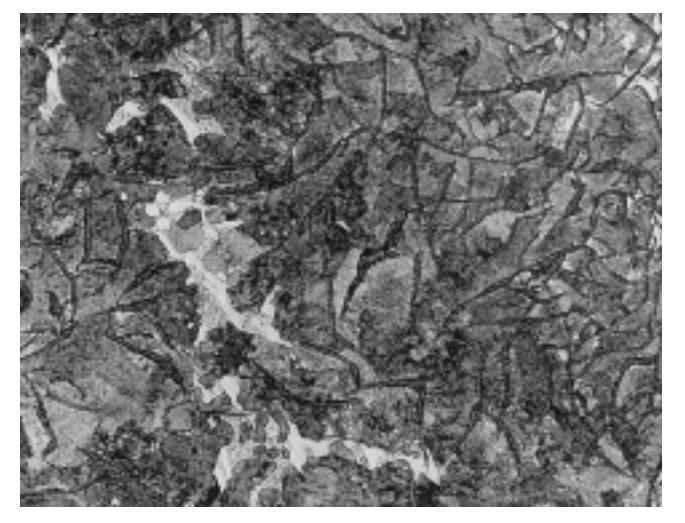
When these two eutectics combine, a tertiary iron-carbon-phosphorus eutectic, with a still lower melting point, will occur in the microstructure. An example of this combined eutectic structure is shown in Figs. 18 and 19. Although the melting point for this constituent is not published, it is believed to be lower than the melting points for the individual eutectics.

Fig. 18. Photomicrograph showing tertiary iron/carbon/phosphorus eutectic in a predominantly pearlite matrix gray cast iron; (400X, nital etch).

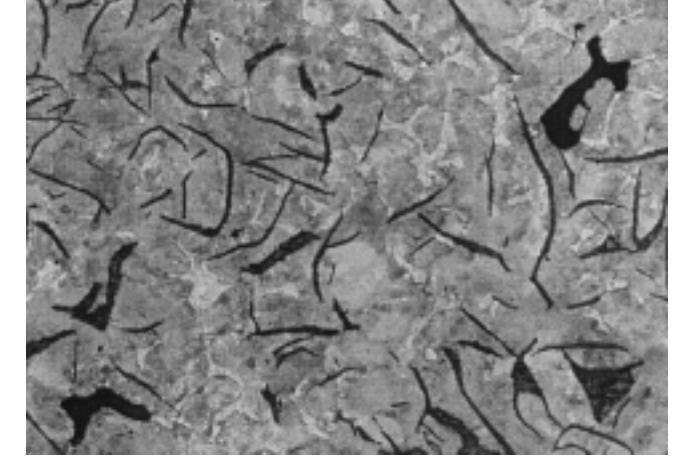
Since these eutectics are the last to solidify, they can be present in the cast iron structure as liquid surrounded by solid, and can be drawn from thin sections to feed thick sections. The consequence can be microscopic shrinkage voids in thin sections. These voids have a shape that is similar to the carbide and steadite constituents that would be found in the structure. Figures 20–23 show an example of the microscopic voids that form from drawing the liquid eutectic phases from thin sections.

Fig. 21. Photomicrograph showing same area seen unetched in Fig. 20 to further illustrate nature of matrix associated with void. Matrix is predominantly pearlite; white constituent is steadite; (200X, nital etch).

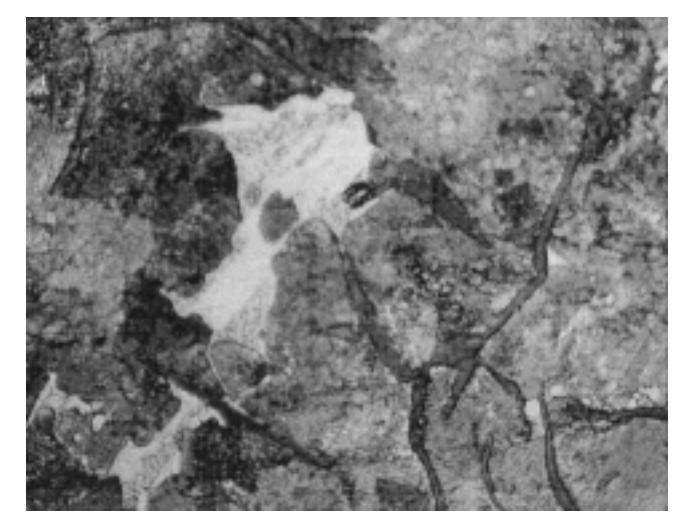
Fig. 19. Photomicrograph showing tertiary iron/carbon/phosphorus eutectic in a pearlite matrix gray cast iron; (1000X, nital etch).

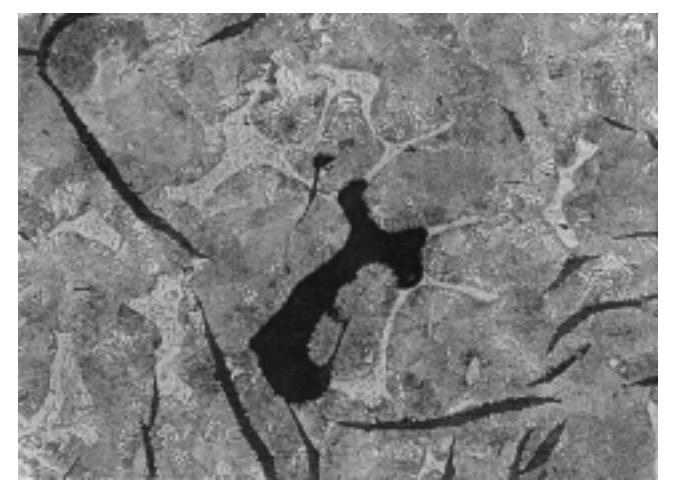
Fig. 22. Photomicrograph showing same void seen at lower magnification in Fig. 22. Note how void appears to be associated with steadite phase that is present in structure; (400X, nital etch).

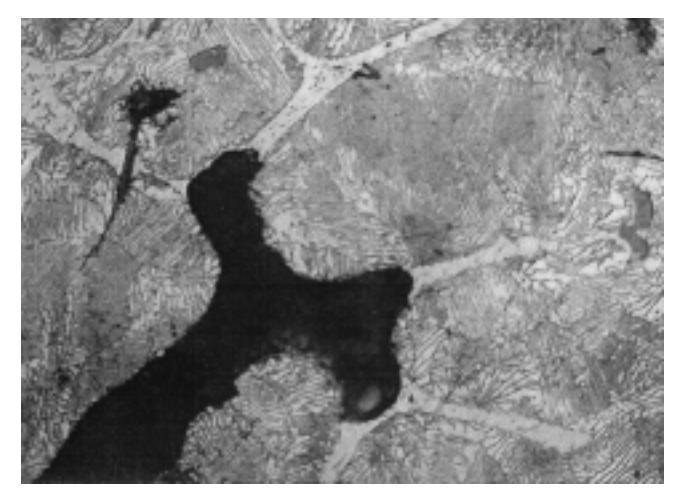
Fig. 23. Photograph showing same area seen at lower magnification in Figs. 21 and 22 to further illustrate how void that appeared as "shrinkage" in Fig. 20 is actually the absence of steadite; (1000X, nital etch).

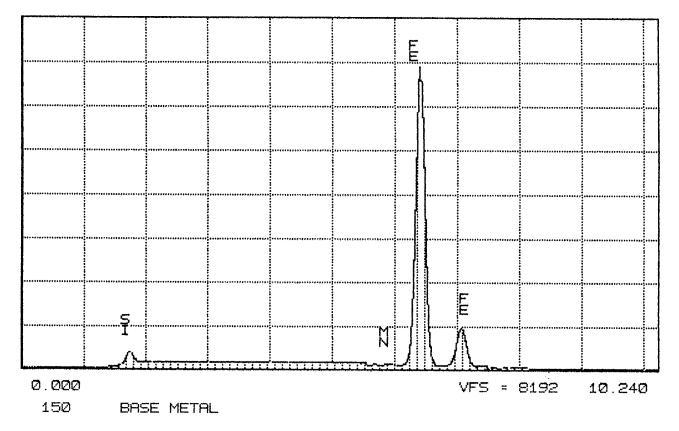
Fig. 27. Spectrum of elements representing base metal in Fig. 26.

Sometimes, the dross is associated with undissolved or partially dissolved inoculant. Figure 26 shows an example. In this instance, the structure on one side of a demarkation line from the dross will have a normal silicon level, whereas the structure on the opposite side will have a high Si level. Energy dispersive x-ray (EDX) spectrographic analysis has been helpful in identifying this type of dross defect. Figures 27 and 28 show a typical example of analysis in the normal structure vs. analysis in the dross region.

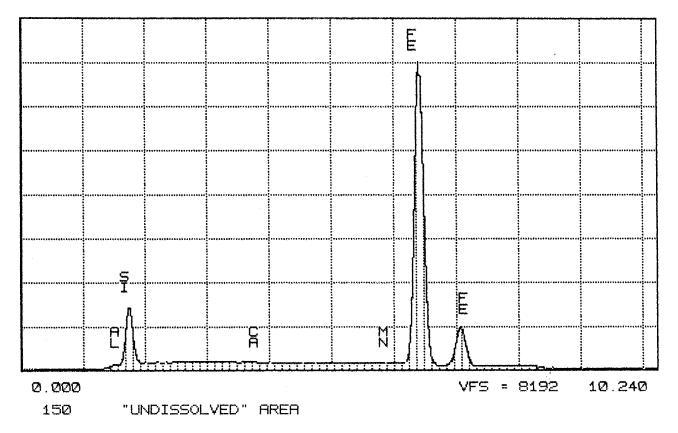
Fig. 28. Spectrum of elements representing partially dissolved inoculant in Fig. 26.

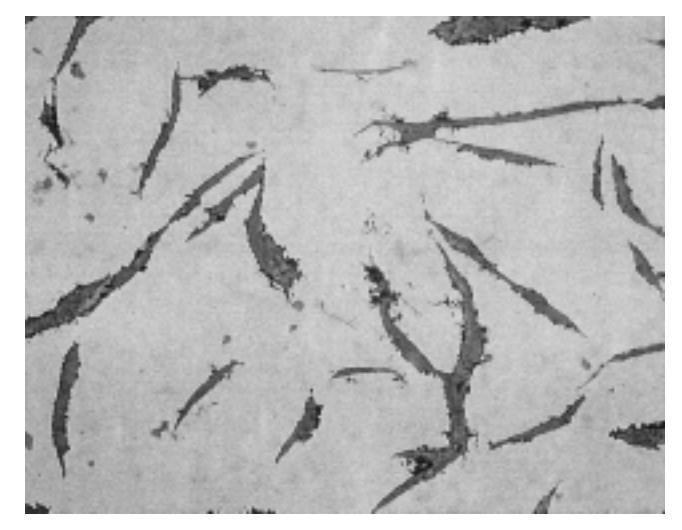
Widmanstätten graphite can occur in cast iron as the result of lead contamination. Other elements are also known to cause this problem. Lead levels as low as 0.005% have been known to create the Widmanstätten graphite. Widmanstätten graphite occurs after solidification with the precipitation of carbon atoms on crystallographic planes creating a spiky appearance to existing graphite flakes. If the condition becomes significant, the precipitation onto crystallographic planes can occur, aside from the primary graphite flakes, creating hatch marks in the structure. Figures 29–31 show Widmanstätten graphite in the *unetched* structure and Figs. 32–34 show the Widmanstätten graphite in an *etched* structure.

Fig. 30 Photomicrograph showing same area seen at lower magnification in Fig. 29. Note that graphite appears "fuzzy." Also note that other graphite forms have precipitated within regions between flakes; (400X, unetched condition).

Often, this graphite structure is associated with phosphorusrich steadite regions. Research^{1,2} has shown that this graphite type can be controlled with the addition of rare earth elements, primarily cerium. As a consequence, the condition does not often occur in ductile cast iron because of the presence of rare earth elements in the treatment alloy. If the condition is occurring in gray cast iron, it can be controlled by eliminating the lead. However, inoculation with a cerium-bearing inoculant can also reduce the effect.

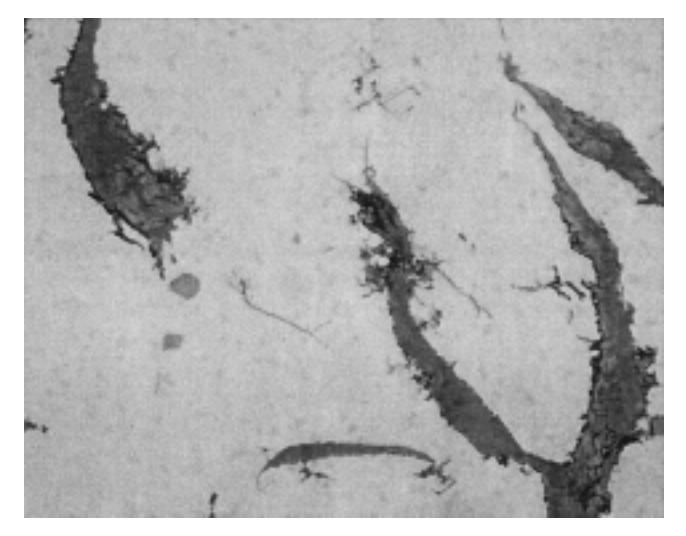
Fig. 31. Photomicrograph showing same area seen at lower magnification in Figs. 29 and 30. Note that "fuzzy" graphite is consequence of small fingers of graphite growing on sides of graphite flakes. Also note graphite forms with thin graphite forms in between graphite flakes toward middle and middle top; (1000X, unetched condition).

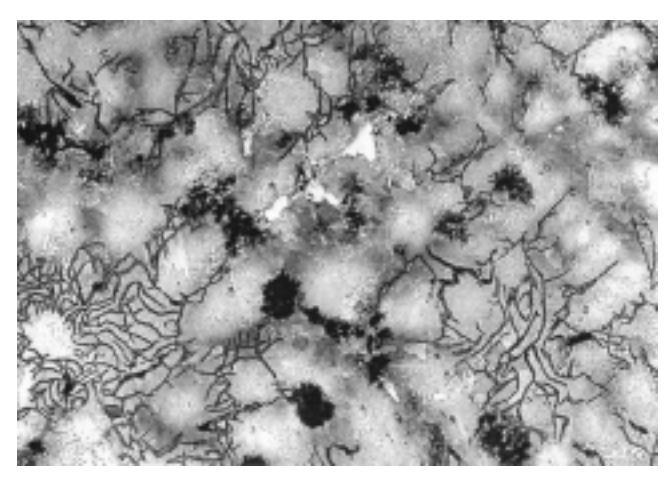
Fig. 32. Photomicrograph showing a pearlitic gray cast iron with Widmanstätten graphite. This area is shown at progressively higher magnifications in Figs. 33 and 34; (100X, nital etch).

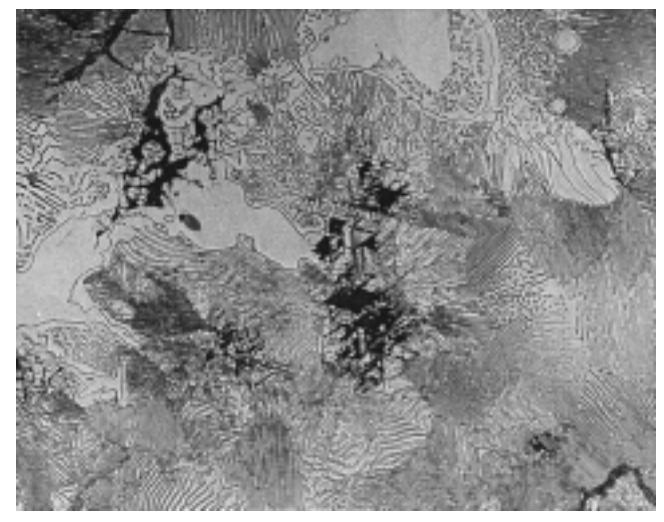
Fig. 33. Photomicrograph showing same area seen at lower magnification in Fig. 32 to illustrate Widmanstätten form of graphite. Note that graphite has precipitated at angles representative of crystallographic planes; (400X, nital etch).

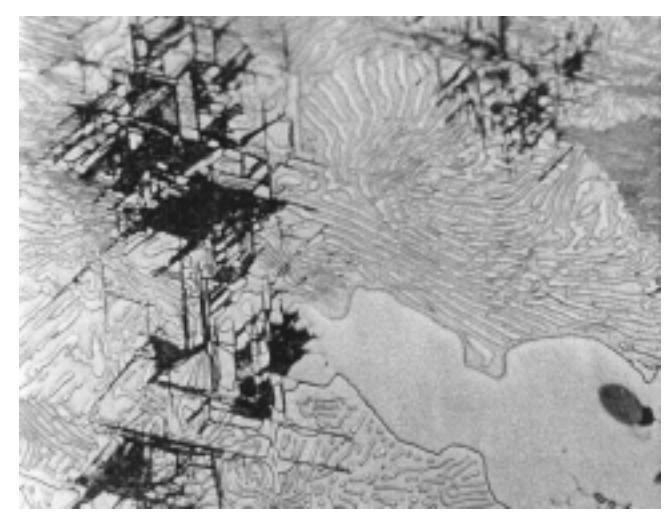
Fig. 34. Photomicrograph showing same area seen at lower magnification in Figs. 32 and 33 to further illustrate graphite precipitated on crystallographic planes; (1000X, nital etch).

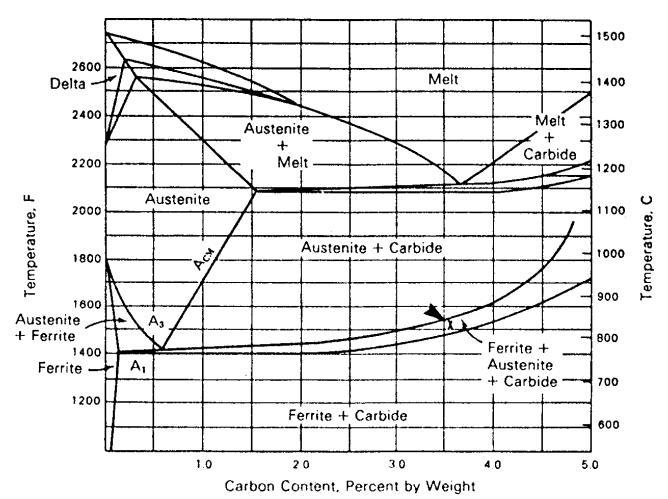
Fig. 37. Shown is iron-iron carbide-silicon ternary diagram sectioned at 2% silicon. "At the tip of the arrow head, X" shows austenitizing temperature reached, in three-phase region indicated by arrow, in two castings examined. Reprinted from "Iron Casting Handbook," American Cast Metals Association.

To normalize or anneal ductile cast iron, the casting must be heated to a high enough temperature for the matrix to become completely austenite. In the two examples, the austenitizing temperature reached the three-phase region, indicated by the arrow in the phase diagram in Fig. 37.

As a consequence, the austenite that was present transformed to the desired pearlite or ferrite constituent. However, the ferrite or pearlite that was present in the structure, but was not transformed, remained intact as the sample was cooled. The structures shown in the photomicrographs reflect both the transformed constituents and the untransformed constituents. The untransformed constituents are the cause of the unusual shapes in the photomicrographs.

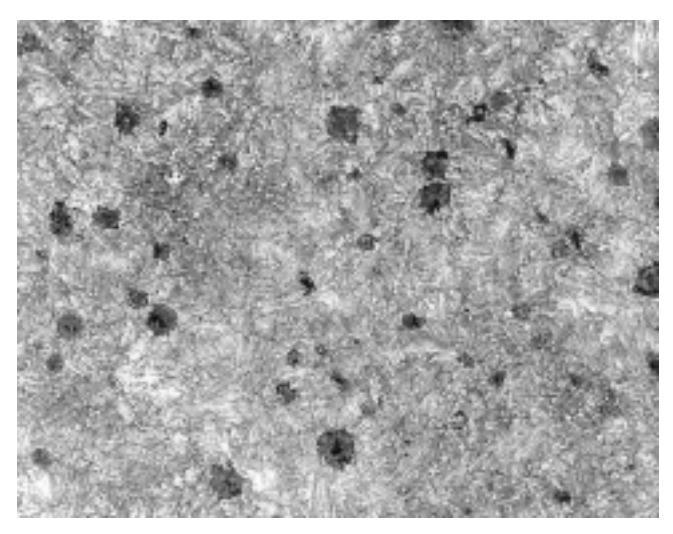
Cast irons that are quenched and tempered to form martensite can have unusual microconstituents. In addition to the expected martensite, an unexpected white constituent in the structure can occur. This white constituent is shown in Figs. 38 and 39 for ductile iron and in Figs. 40 and 41 for gray iron. The constituent is *retained austenite*.

Carbon can stabilize austenite and, since cast irons are hypereutectoid, the austenitizing temperature can affect the amount of carbon dissolved in the austenite, prior to quenching. As the temperature increases above the eutectoid reaction, the amount of carbon dissolved in the austenite increases. When this iron is quenched, some of the high carbon austenite is retained, leaving a mixed structure of martensite and austenite. More specifically, this is a mixed structure of martensite and high carbon austenite.

Fig. 38. Photomicrograph illustrating retained austenite in a martensitic ductile cast iron. Small angular white constituents (arrows) in matrix are retained austenite; remainder of matrix is martensite; (200X, nital etch).

To prevent retained austenite from occurring in quenched martensitic cast iron structures, the temperature from which the iron is quenched should be lowered to a temperature immediately above the eutectoid. The correct temperature may require trial and error to establish it for individual irons. The reason is that the eutectoid temperature varies significantly, as a function of Si, and no single temperature for gray iron or for ductile iron can be stated. Nickel also stabilizes austenite. As Ni content increases, so does the tendency for retained austenite.

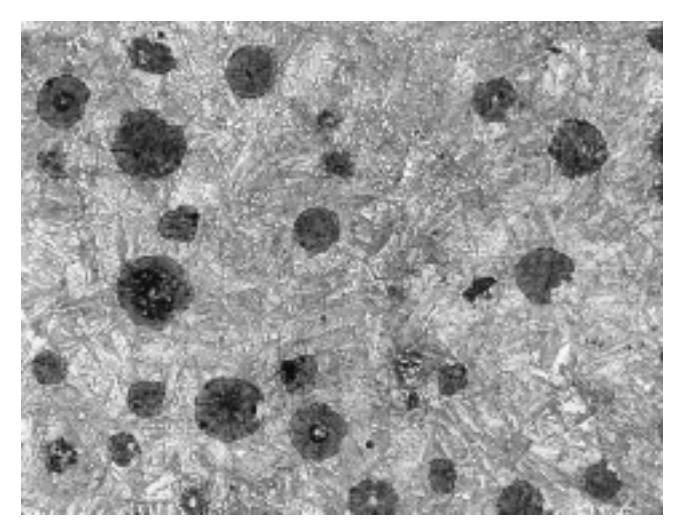
Fig. 39. Photomicrograph illustrating retained austenite in a martensitic ductile cast iron. Small angular white constituents (arrows) in matrix are retained austenite; matrix is martensite; (400X, nital etch).

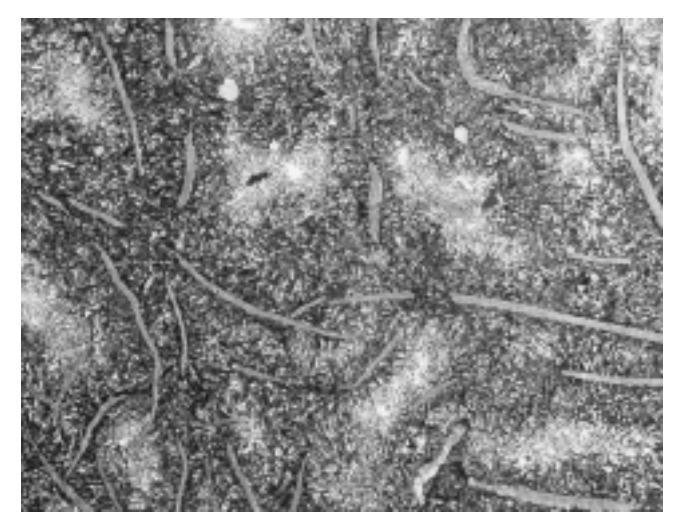
Fig. 40. Photomicrograph illustrating retained austenite in a martensitic gray cast iron. White angular constituent in structure is retained austenite; remainder of matrix is martensite; (400X, nital etch).

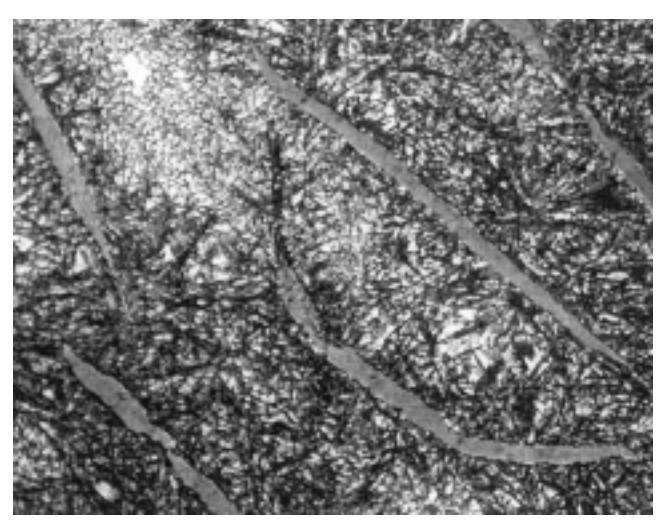
Fig. 41. Photomicrograph illustrating retained austenite in a martensitic gray cast iron. White angular constituent is retained austenite; remainder of matrix is martensite; (1000X, nital etch).

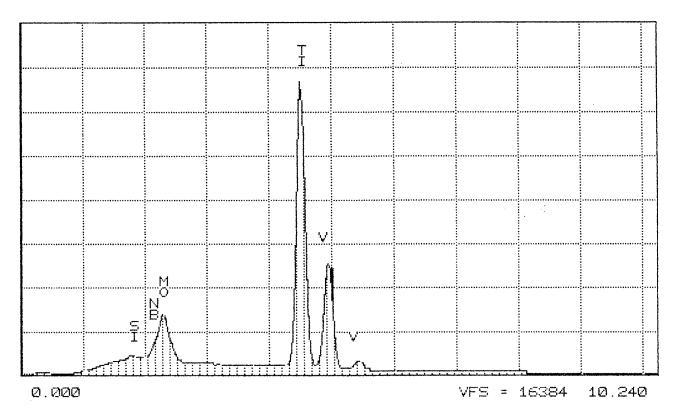
In Problem 1, the microstructure at the tensile fractured surface had a required graphite nodularity (greater than 80%) and pearlite content (greater than 50%), but the structure had a high incidence of intercellular carbides (Fig. 42). As shown in Fig. 43, EDX spectrographic analysis revealed these carbides were high in titanium, vanadium, molybdenum and niobium. These carbides significantly detracted from the ability of the casting to meet the elongation requirements.

Fig. 43. Spectrum of elements representing intercellular carbides in Fig. 42.

Correcting these problems required different approaches. For Problem 1 (failing to meet the elongation requirement), closer scrutiny of the charge material was required to minimize the influx of tramp elements.

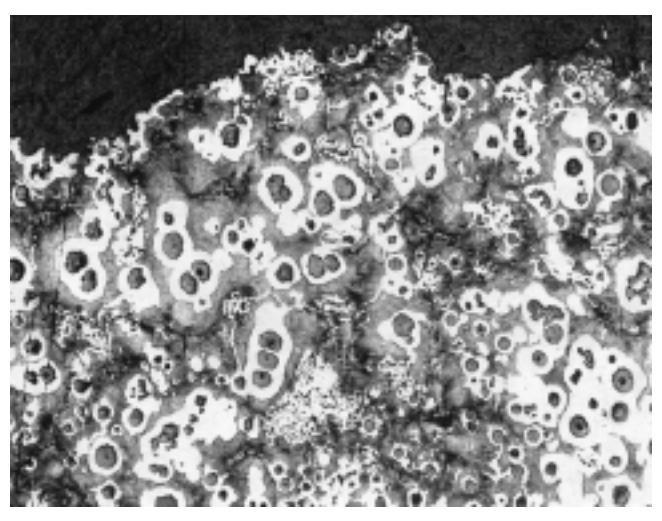
In Problem 3, the microstructure exhibited an acceptable pearlite content (Fig. 45), but the graphite nodularity (Fig. 46) was not acceptable. Poor nodularity negatively affects both the yield strength and elongation.

Fig. 45. At 100X, casting's pearlitic content is acceptable (80%).

For Problem 3 (failing to meet both yield strength and elongation requirements), the magnesium/cerium content was not adequate as the result of fade or ineffective treatment.

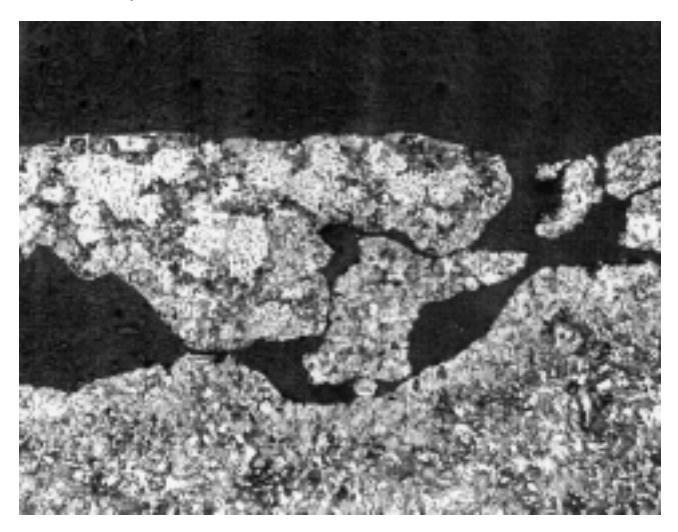
Fig. 49. Photomicrograph illustrating same area shown unetched in Fig. 46. This etched structure further exemplifies differences between individual layers; (50X, nital etch).

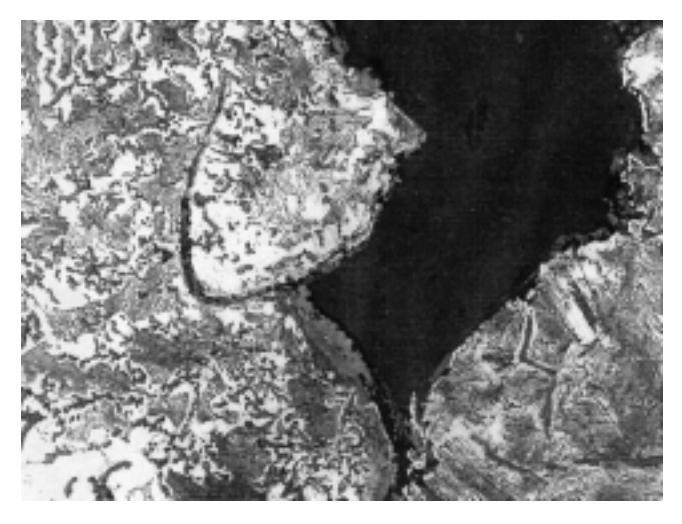
In lesser amounts, the carbonaceous material provides a reducing atmosphere in the mold, which minimizes casting surface oxidation and improves casting surface quality or *peel*. It is often removed from the casting surface by casting cleaning operations. As the level of these volatile gases increases, the severity of the defect increases and the lustrous carbon folds into solidifying metal, causing unacceptable cold shuts and laps. Figures 47–50 show a typical example of a lustrous carbon defect. Figures 47 and 49 illustrate the depth of the discontinuities and their microstructural differences. Figures 48 and 50 illustrate a lap defect resulting from folding the graphite layer into the metal.

Fig. 50. Photomicrograph illustrating same area shown unetched in Fig. 47. The etched structure further exemplifies differences between two regions and graphite film that developed from lustrous-carbon defect; (400X, nital etch).

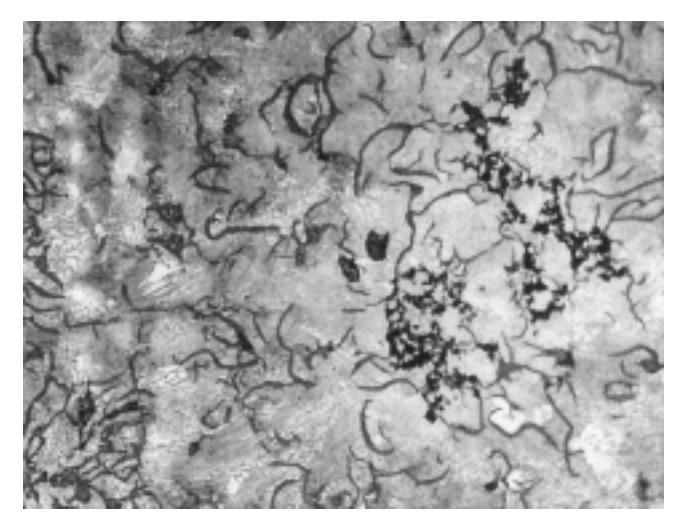
structure. Figures 52 and 53 compare the pearlite in the surrounding matrix with the fine pearlite in the hard spot. Energy dispersive x-ray analysis of the matrix revealed traces of Sn, Cr and S in the fine pearlite that were not present in the coarse pearlite. The results of this EDX analysis are shown in Figs. 54 and 55. The Sn content of this casting was 0.14%, Cr was 0.09% and the S content was 0.12%.

Fig. 52. Photomicrograph emphasizes fine pearlite in "hard spot" in Fig. 51. See Fig. 54 for composition of pearlite matrix in this "fine" area; (400X, nital etch).

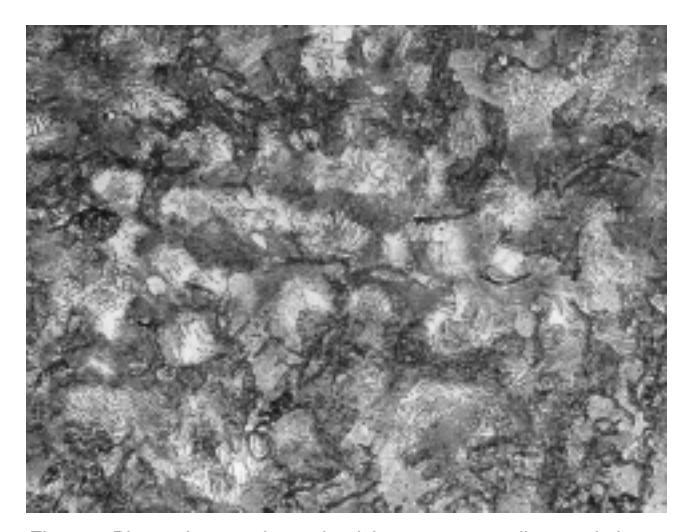
Fig. 53. Photomicrograph emphasizing coarse pearlite matrix in Fig. 51. See Fig. 55 for composition of matrix in this coarse area; (400X, nital etch).

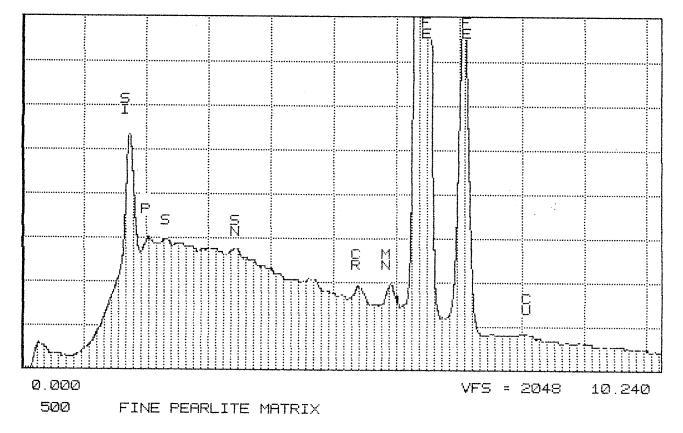
Fig. 54. Spectrum of elements representing fine pearlite in Fig. 52.

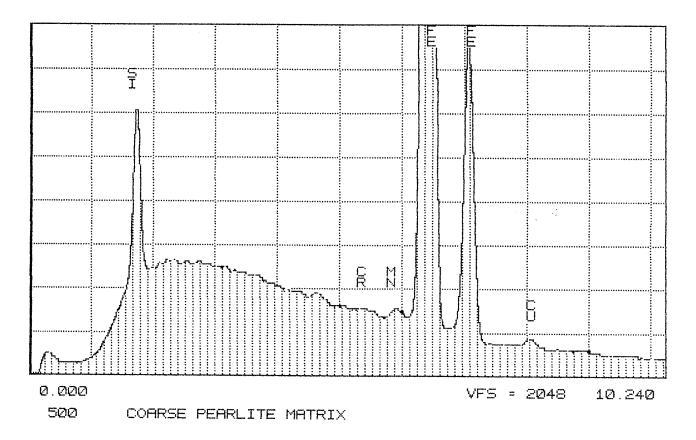
Fig. 55. Spectrum of elements representing coarse pearlite in Fig. 53.

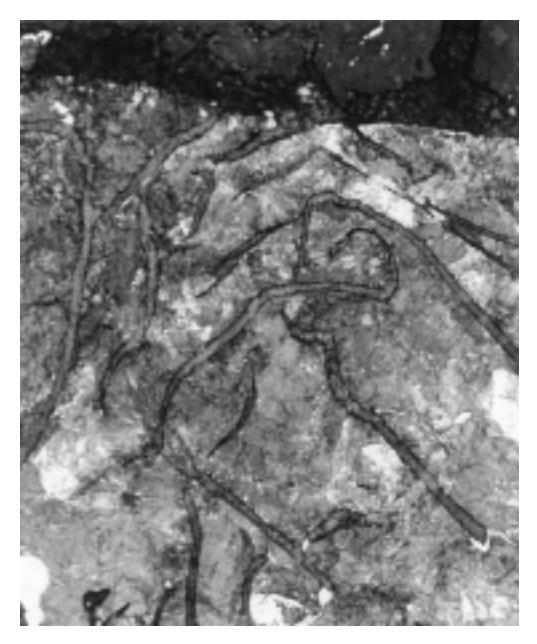
With the new mold filter technology being used today, it has been found that, occasionally, portions of the filter become entrapped in the iron. This is shown in Fig. 56. Apparently, the quality of the iron in the immediate vicinity of the filter segment can be unaffected, as can be seen by comparing Figs. 57 with 58 and 59. However, depending upon what materials might be trapped on the filter, the iron in the immediate vicinity of the filter segment could be compromised. Sometimes, cold shuts and degenerate graphite can occur, as shown in Fig. 60.

Fig. 56. Photomicrograph showing a cross section where a filter segment was trapped in microstructure; (50X, nital etch).

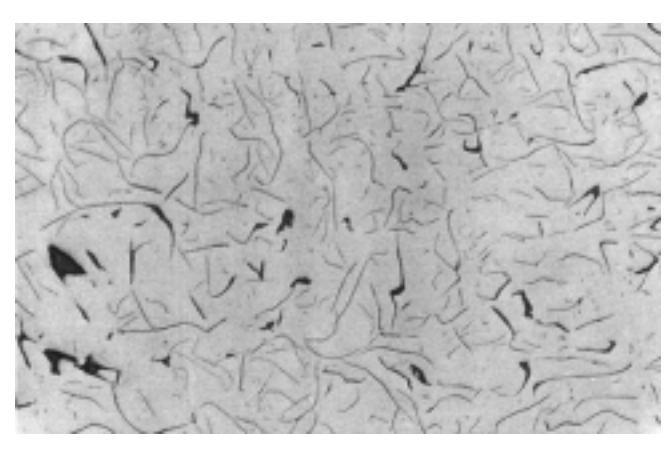
Fig. 57. Photomicrograph showing same area seen at lower magnification in Fig. 56. This photograph illustrates that no ill effects have occurred with respect to microstructure quality; (400X, nital etch).

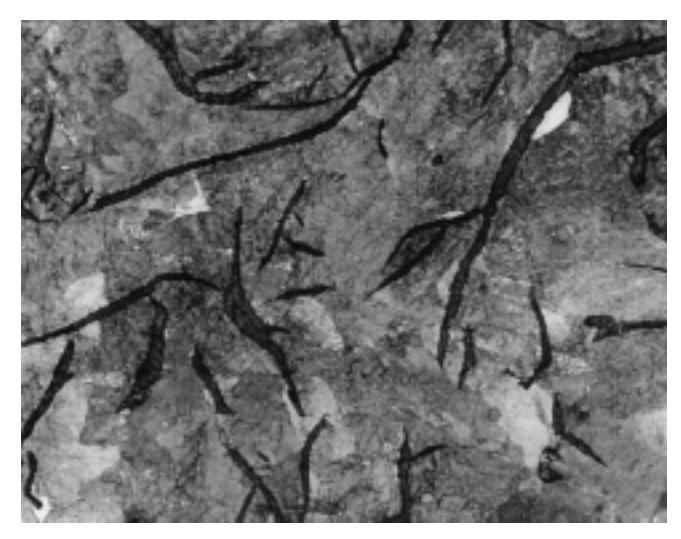
Fig. 58. Photomicrograph showing graphite structure of casting, away from defect; (100X, unetched condition).
